CENTRAL ARIZONA GOVERNMENTS
**STRATEGIC TRANSPORTATION
SAFETY PLAN**

SAFETY REVIEW MEMORANDUM

September 15, 2016

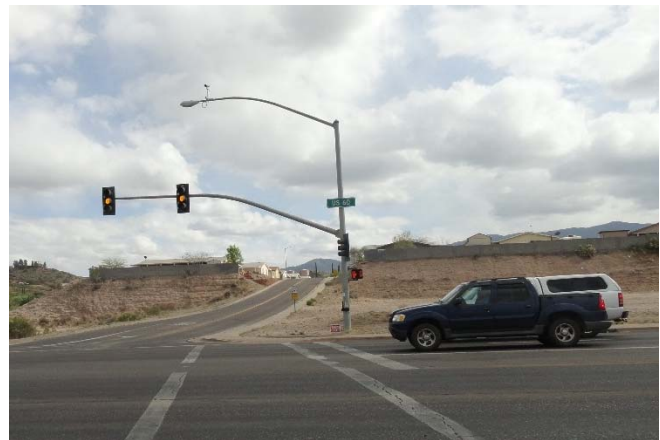
Figure 3: Faded Striping & View of Signal Heads

- 2. Add Reflective Tape to Backplates** – Adding reflective tape around the outside of the signal heads on the backplate will help the signals be seen more clearly. This should help with visibility during dusk and dark conditions.

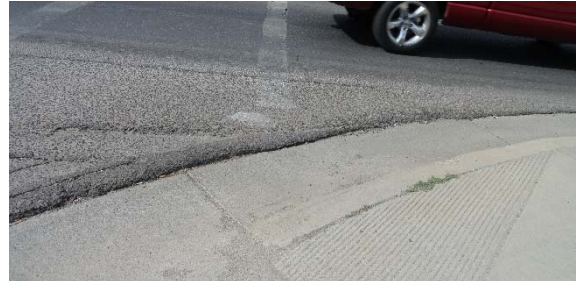
Figure 4: Asphalt Next to Gutter Lip being pushed and causing a trip hazard.

6. Add Detectable Warnings	Included in Ramps	N/A	N/A	ADA, included in price of ramps.
7. Remove Trip hazard- Asphalt next to gutter lip	\$80.00	N/A	N/A	ADA

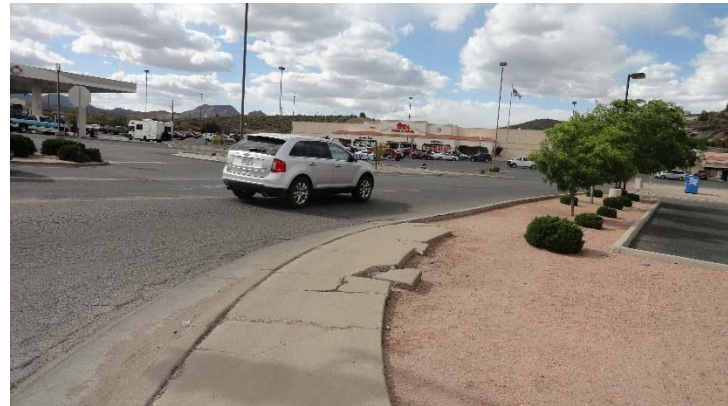
Figure 5: Sidewalk deterioration and ending looking towards Globe Food Mart.

8. Sidewalk Repair and Extension	\$2,831.42	N/A	N/A	ADA
9. Update Pedestrian Push Buttons	\$8,320.00	N/A	N/A	ADA
10. Install Directional Pedestrian Ramps	\$2,500.00	N/A	N/A	ADA

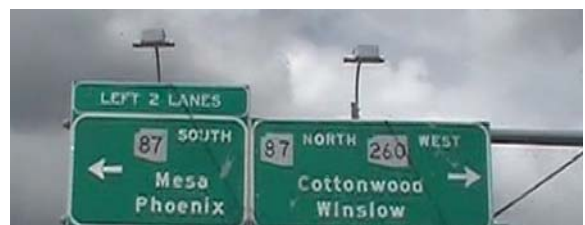
Figure 7: Overhead Signs

1. **Restripe Intersection Crosswalks**– The intersection has crosswalk striping but it is fading.
2. **Update Signage** – The signage prior to the intersection is button copy. This is an old style of sheeting that is no longer reflective. Replacing with new retro-reflective sheeting will help the signs stand out during dark hours.

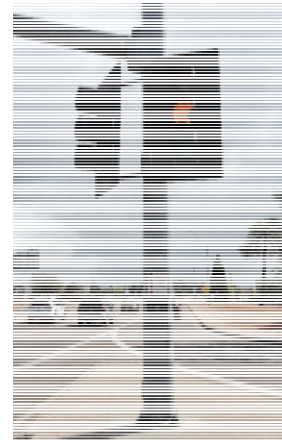
Figure 8: Signal heads on southwest quadrant.

7. **Add a Leading Pedestrian Interval to Signal Phasing** - Vehicles often do not notice pedestrians trying to cross the street when a green light is given. Adding pedestrian intervals to the signal timing gives pedestrians a head start into the intersection before the related vehicle green time. This puts the pedestrian into the crosswalk before vehicles begin their through or turn movements.

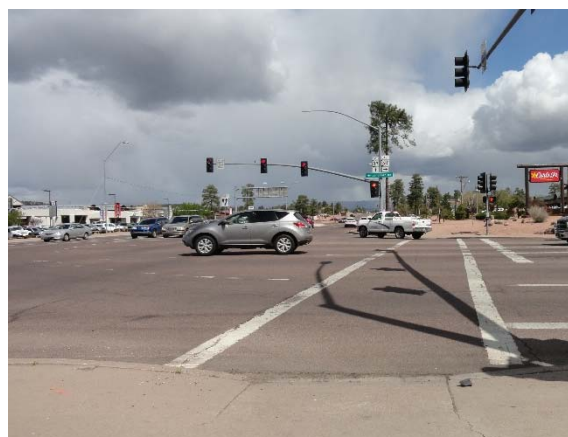
Figure 9: Pedestrian ramp going from the southeast quadrant to the northeast quadrant.

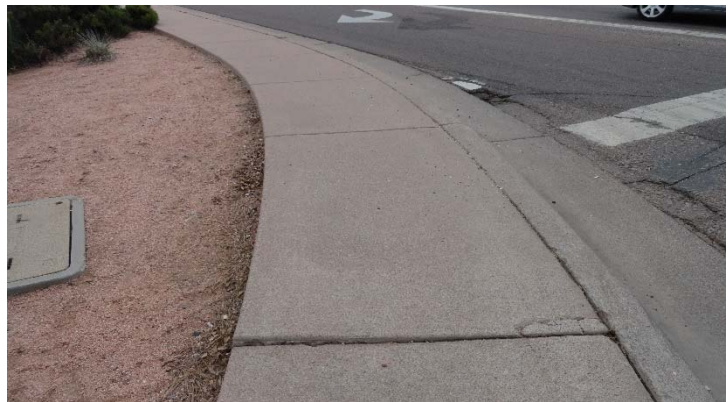
Figure 11: Sidewalk edge drop-off

- 5. Fix Sidewalk Edge Drop-Off** – On the sides of the sidewalk on the southwest quadrant, the edge drops roughly 2 inches, having this fixed will prevent pedestrians from falling off the edge.

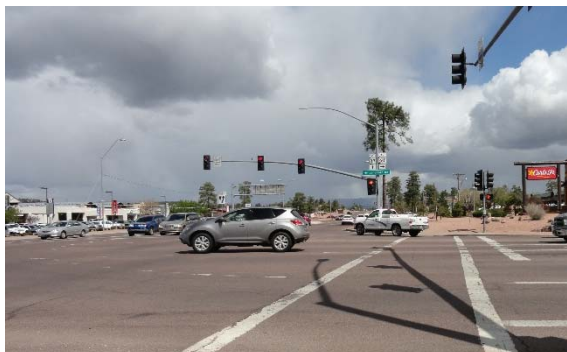
Figure 12: Pedestrian ramp going from the southeast quadrant to the northeast quadrant.

6. **Update Pedestrian Facilities** – Only two of the crossings have detectable warnings at the ends of the ramps. Adding detectable warnings at all ramps will help pedestrians with disabilities know where the roadway is located.
7. **Install Flashing Yellow Arrows** – Installing Flashing Yellow Arrows, in place of the green ball for permissive left turn movements, is shown to be easier to understand for drivers.
8. **Install Protected Only Left Turn Phasing** – Installing protected only left turns on the north and southbound approaches would increase the safety by eliminating conflict points.
9. **Provide Pedestrian Lighting** – Pedestrian lighting would improve visibility for pedestrian and pedalcyclists and other road users.
10. **Install Red Light Running Cameras** – This may help with the reduction in angle and left turn crashes.

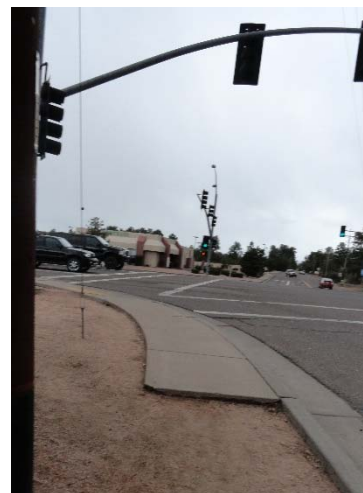
Figure 13: Sidewalk end on southwest quadrant.

11. **Connect Sidewalk** – The sidewalk currently ends at the curb return on Granite Dells Road on the west side of the intersection. Pedestrians were observed either walking through the dirt or on the roadway. Connecting the sidewalk will eliminate conflicts between pedestrians and vehicles making it safer for both modes of transport.

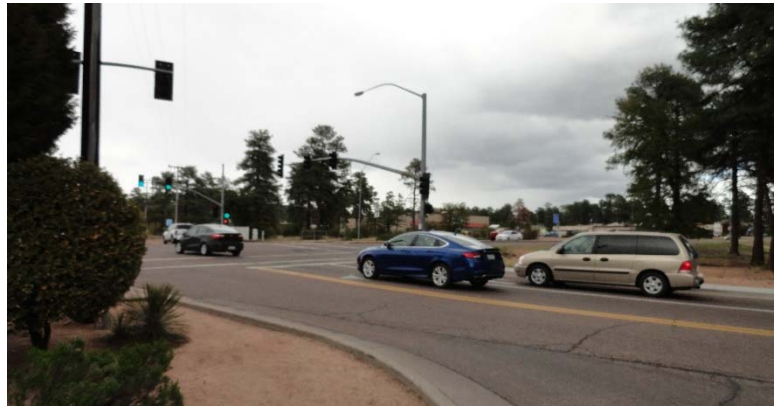
Figure 14: View from grocery store entrance.

- 12. Move Grocery Store Drive** – Moving the grocery store driveway, on the south leg, further south would allow for better sight distance and help eliminate conflict.
- 13. Realign SR 260 Roadway** – Realigning the roadway to come in at 90 degrees will help with drivers turning decisions.
- 14. Realign Granite Dells Road** – Realigning Granite Dells Road and eliminating the curve would help with the sight distance problems.

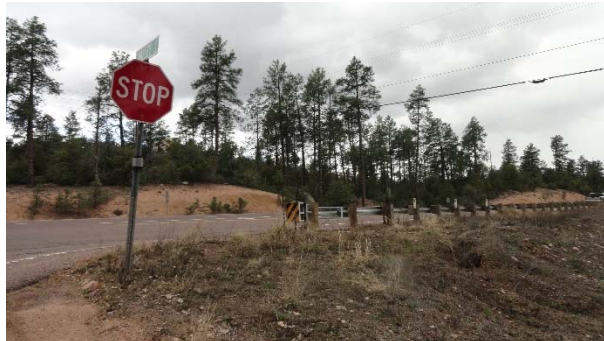
Figure 16: Incline on Valley Road.

- 14. Raise Valley Road** – Valley Road currently comes in on an incline. The roadway could be raised to be even with the mainline and a better sight distance could be achieved.

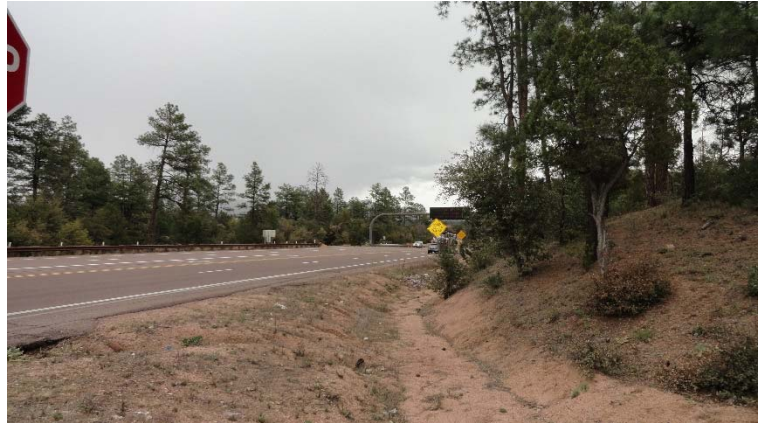
Figure 18: Looking east from Highland Drive.

11. **Cut Back Embankment** – Coming from Highland Drive, the embankment creates a sight distance constraint. Cutting it back would increase the sight distance at the intersection for left turning traffic.
12. **Wild Animal Crossings** – Installing over or underpasses could reduce the number of wild animals crossing the highway near Valley Road / Highline Drive and SR 260.
13. **Realign the side streets** – Aligning the two side streets opposite of each other simplifies intersection turning movements and is more consistent with driver expectations.

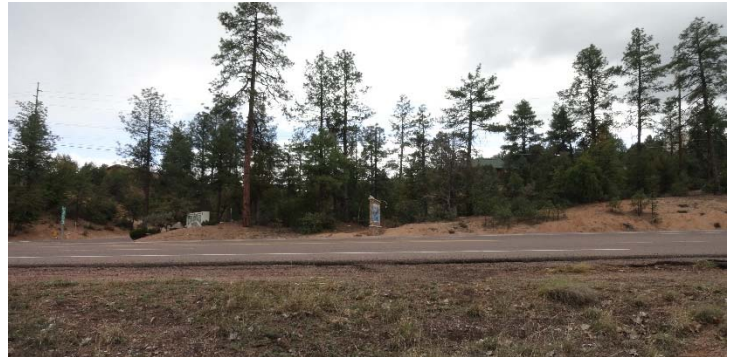
Figure 19: Looking from ditch on the south side of the road.

- 15. Move or eliminate ditch on south side of SR 260** – On the south side of SR 260 there is a steep ditch. Moving this further from the travelway, would allow the drivers more time to recover. If the ditch is completely eliminated, it would provide a wider clear zone.

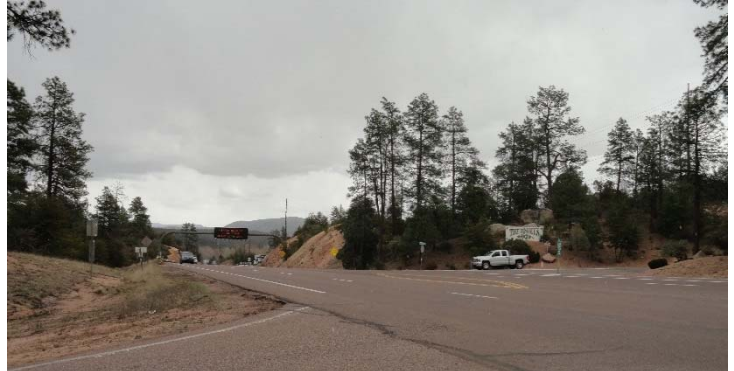
Figure 20: Looking east from Valley Road.

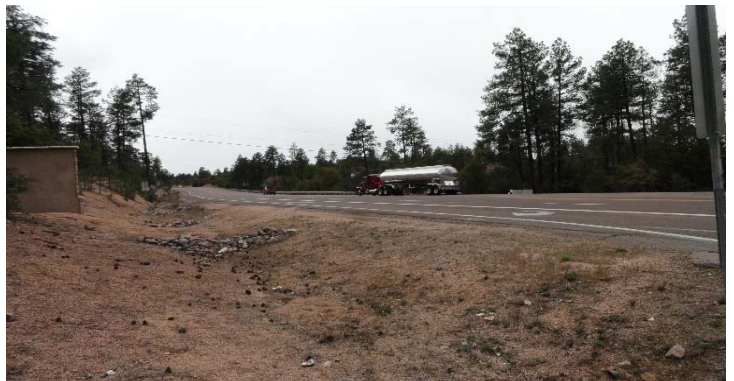
Figure 21: Ditch near Highland Drive.

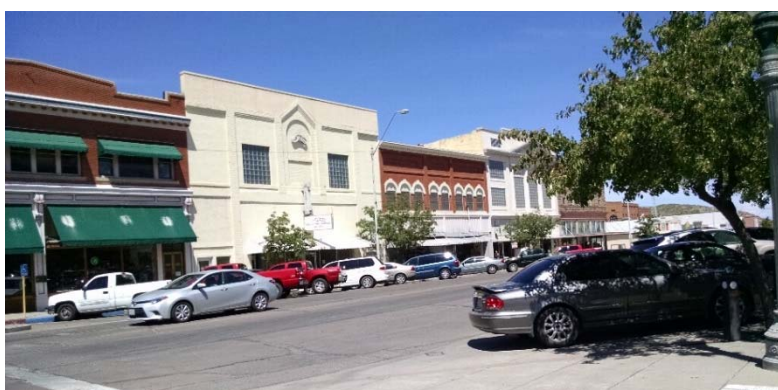
Figure 23: Parking on north leg of intersection.

- 1. Parking Spots** – Currently the most common crash type is Rear-to-Side. This is indicative of sight distance problems with cars backing out of spots. Options to reduce these crashes include: eliminating angled parking, reducing the number of angled parking spots near the intersection, or changing the angled parking to parallel or back-in only street parking on Broad Street.

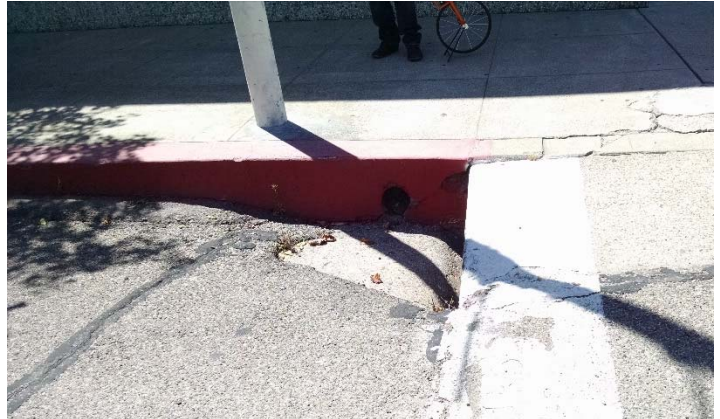
Figure 24: Inlet on southeast quadrant.

- 2. Provide Retroreflective Marking on Fixed Objects near Roadway** –The concrete bench used to delineate the pedestrian area should have a reflectorized sign to help it stand out at night.
- 3. Inlet Hole Southeast Corner** – On the southeast corner there is an inlet hole that poses a risk to pedestrians, bicyclists, and vehicles.
- 4. Restripe Intersection** – The intersection currently has striping but it is faded.
- 5. Update Signing** –The Stop Signs have a 4-Way plaque underneath, but should be updated to say All-Way as this is the most up to date signing standard.

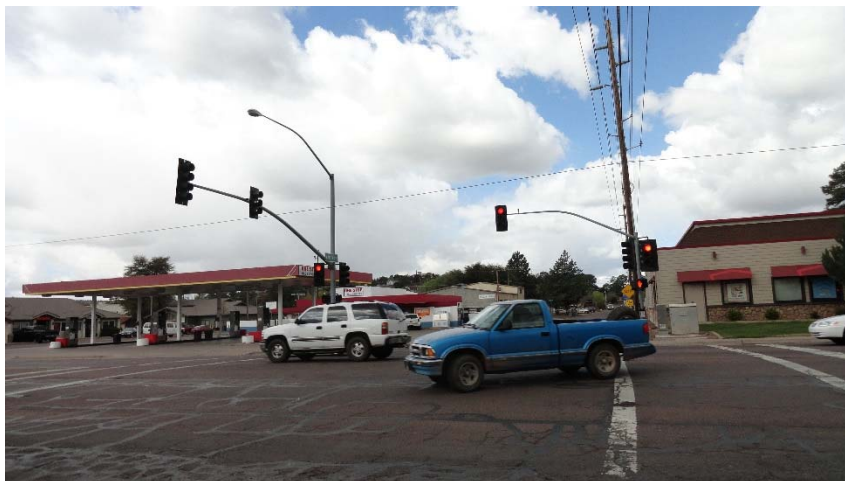
Figure 28: Looking from northeast quadrant towards the west.

- 7. Access Control** – The gas station has access at the southwest quadrant of intersection. The start of the access begins at the curb return, which causes conflicts. The gas station has multiple entrances and exits, so removing the access closest to the intersection would be beneficial with little impact to the gas station. Another option is removing access from the gas station to SR 87 altogether, since the gas station also has access onto/from the side street.

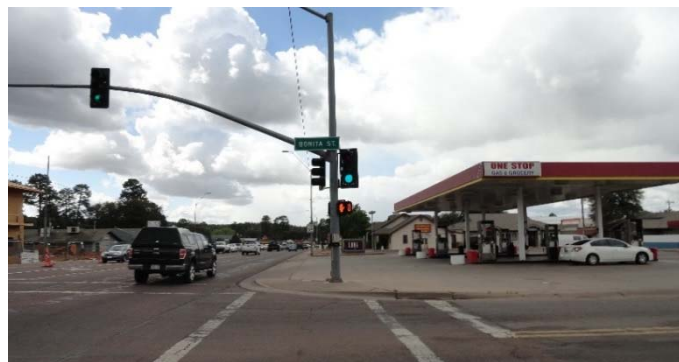
Figure 29: Looking from northwest quadrant towards southwest quadrant.

- 8. Reduce Width of Driveways** – Reduce the width of the driveways on each side of the intersection. One of the driveways is the entire width of the lot.
- 9. Eliminate Access on SR 87** – As there is access to all businesses from the side streets, eliminating access onto the SR 87 would improve safety as well as progression along the mainline.

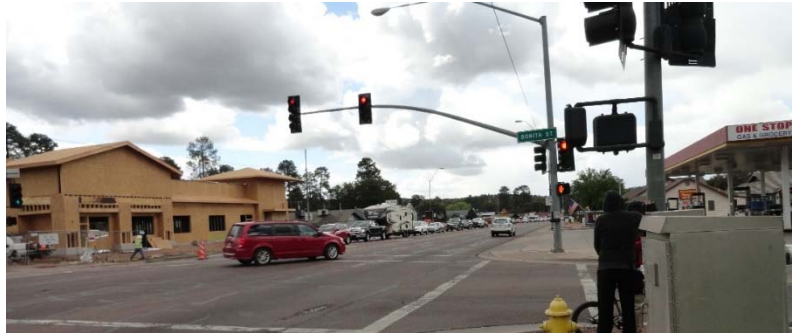
Figure 30: Pedestrian and Bicyclist on NW quadrant unable to stay on sidewalk to push pushbutton.

- 14. Initiate Passive Pedestrian Detection** – Passive pedestrian detection can be used to detect pedestrians without needing a pushbutton.

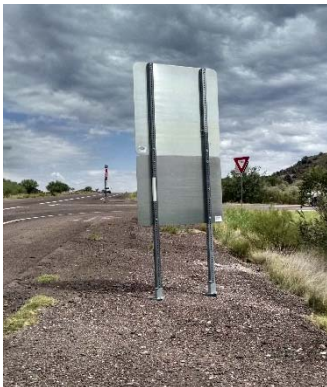
Figure 34: Sign near intersection of SR 87& SR 188. Improper mounting height and breakaway base.

- 5. Breakaway Post Base** – Install breakaway bases on all the signs. With the amount of run-off the road crashes and fixed object crashes it is important that signs have proper bases to help eliminate / reduce injuries when hit.

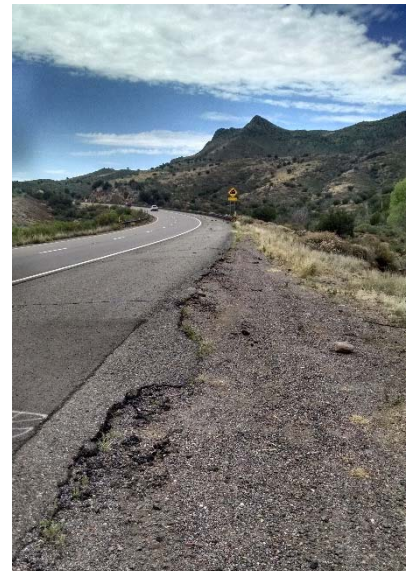
Figure 33: Eroding edge of roadway

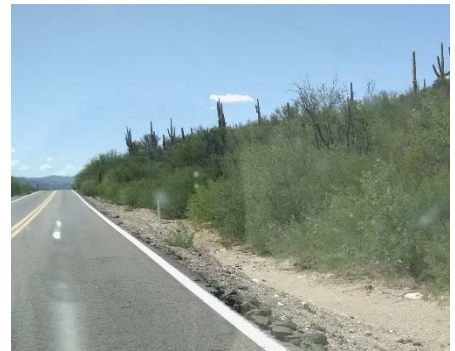
Figure 38: Eroding edge of travelway.

6. **Fix Eroding Edge of Roadway** – Portions of the roadway are eroding. Fixing these would help drivers recover if they run off the road.

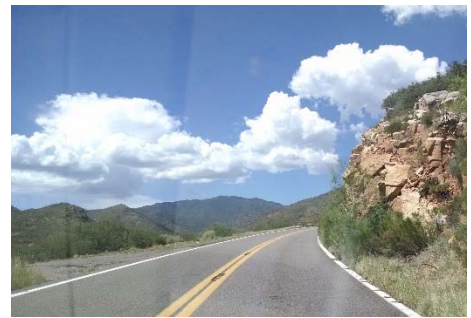
Figure 39: Narrow shoulders, faded centerline striping.

9. **Centerline Rumble Strips** – Currently the entire segment does not have centerline rumble strips. Installing them along the entire segment would help address head-on and sideswipe crashes.

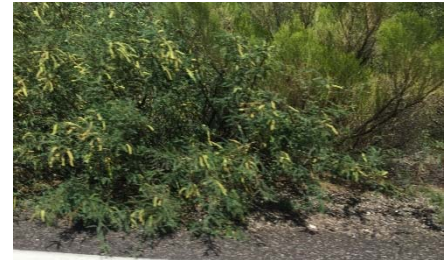
Figure 40: Vegetation encroachment.

11. Trim Overgrowth – Along the route many areas have overgrown foliage that is starting to creep onto the shoulders and roadway, and obstruct sign faces. This limits sight distance, but also encourages people to drive closer to the centerline.

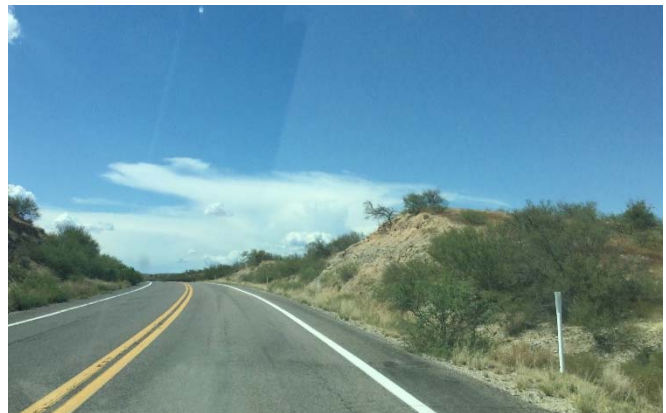
Figure 41: Slight curve delineated with object markers.

15. Chevrons – Add chevrons on curves where advisory speed is 10 MPH less than posted speed limits. Chevrons may also be added to curves where object markers are in place.

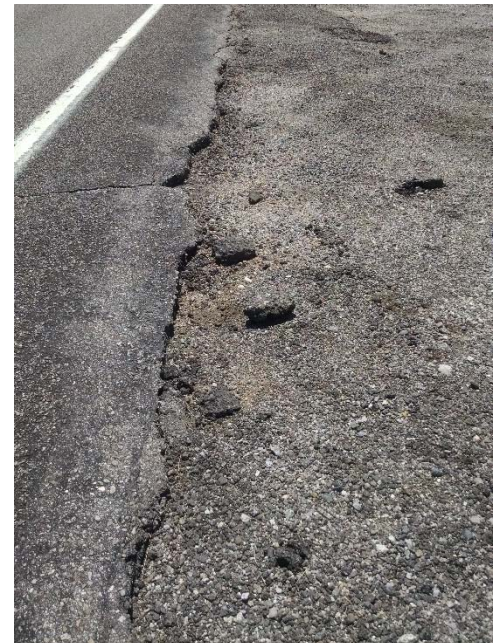
Figure 43: Edge of roadway eroding.

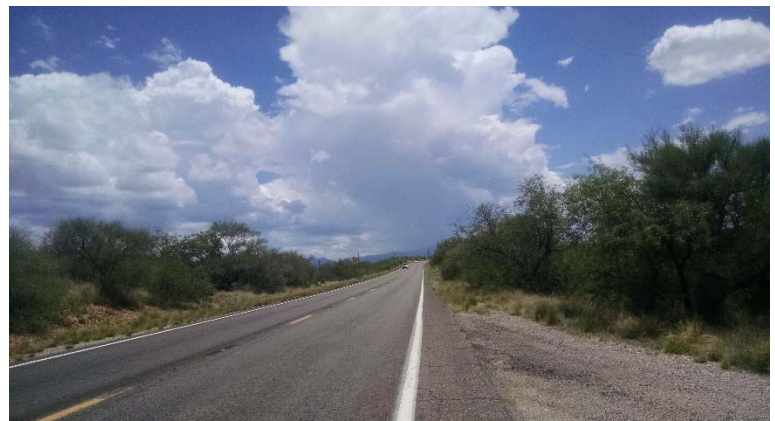
Figure 44: Vegetation close to roadway. Near a pullout.

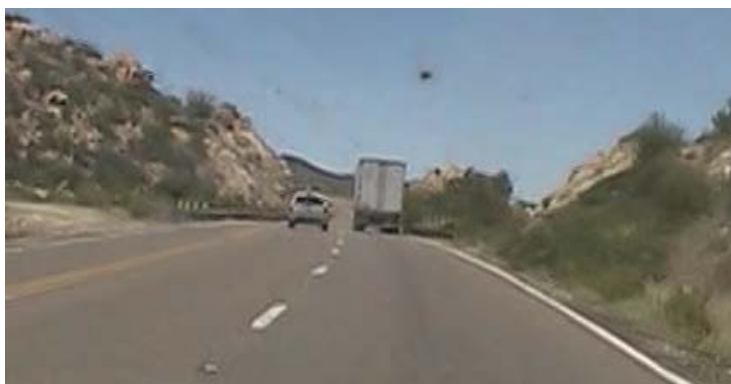
Figure 45: Faded Striping & Small Shoulder

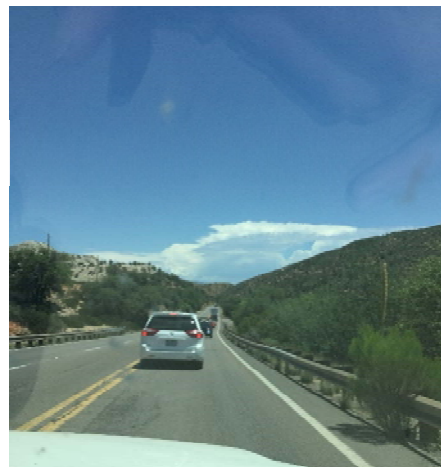
Figure 46: Vegetation Encroaching
