CENTRAL ARIZONA GOVERNMENTS
**STRATEGIC TRANSPORTATION
SAFETY PLAN**

SAFETY REVIEW MEMORANDUM

September 15, 2016

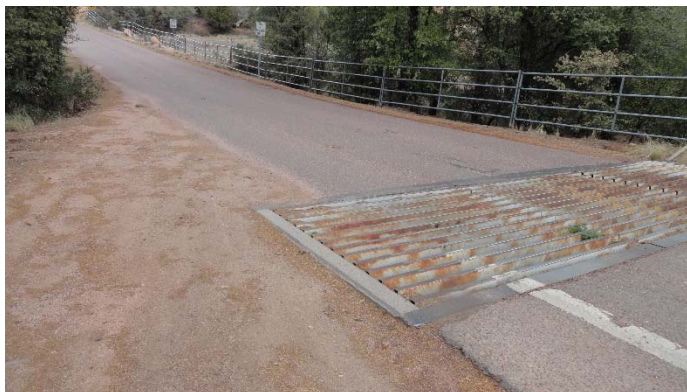
Figure 17: Cattle Guard

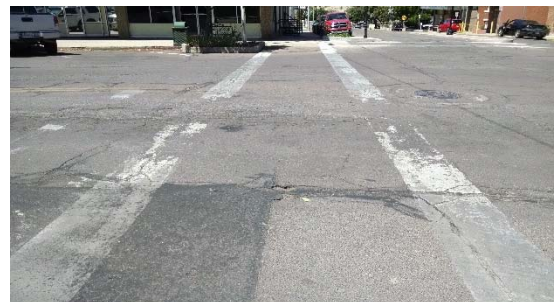
Figure 25: Crosswalk crossing south leg of intersection.

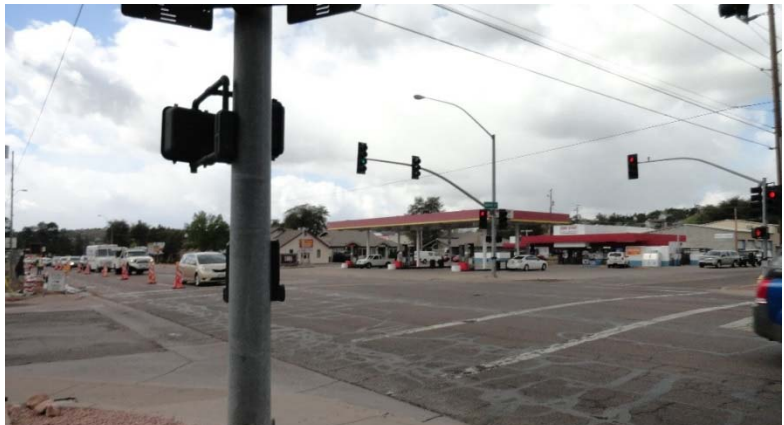
- 1. Add Reflective Tape to Backplates** – Adding reflective tape around the outside of the signal heads on the backplate will increase the visibility of the signals during nighttime and dusk / dawn hours.
- 2. Re-Stripe Intersection** The intersection has striping but needs to be restriped as it is fading. Stop bars and crosswalks were significantly faded. New striping would help drivers, pedestrians, and other road users understand where they should be in the intersection.

Figure 27: Looking from the northeast quadrant.

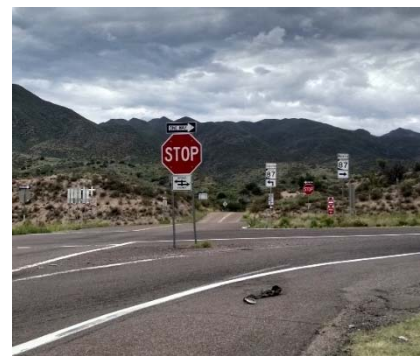
Figure 32: Intersection of SR 87 & SR 188.

1. **Add Yellow/Red Post Reflectors to Side-Road Stop Sign** – Many of the side-roads came in at odd angles and have existing side road warning signs. By adding post reflectors to the signs, attention can be focused on the hard to see side-road entrances.

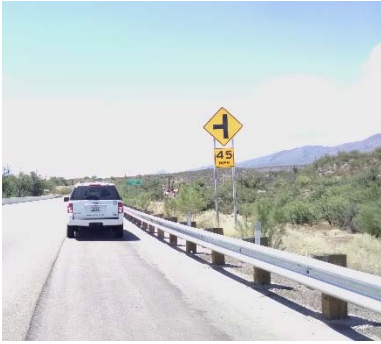
Figure 37: Side Road Left Sign.

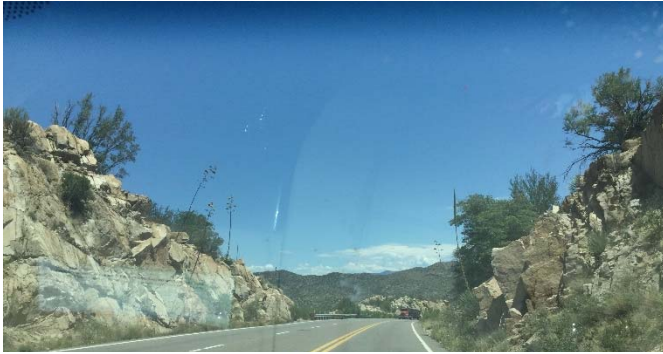
Figure 47: Passing Lane

12. Passing / Climbing Lanes – Though some passing/climbing lanes are provided, adding additional lanes would help to reduce the number of sideswipe collisions.
