**Appendix B**

# CAG Regional Strategic Transportation Safety Plan SR 87/Beeline Highway at Longhorn Road

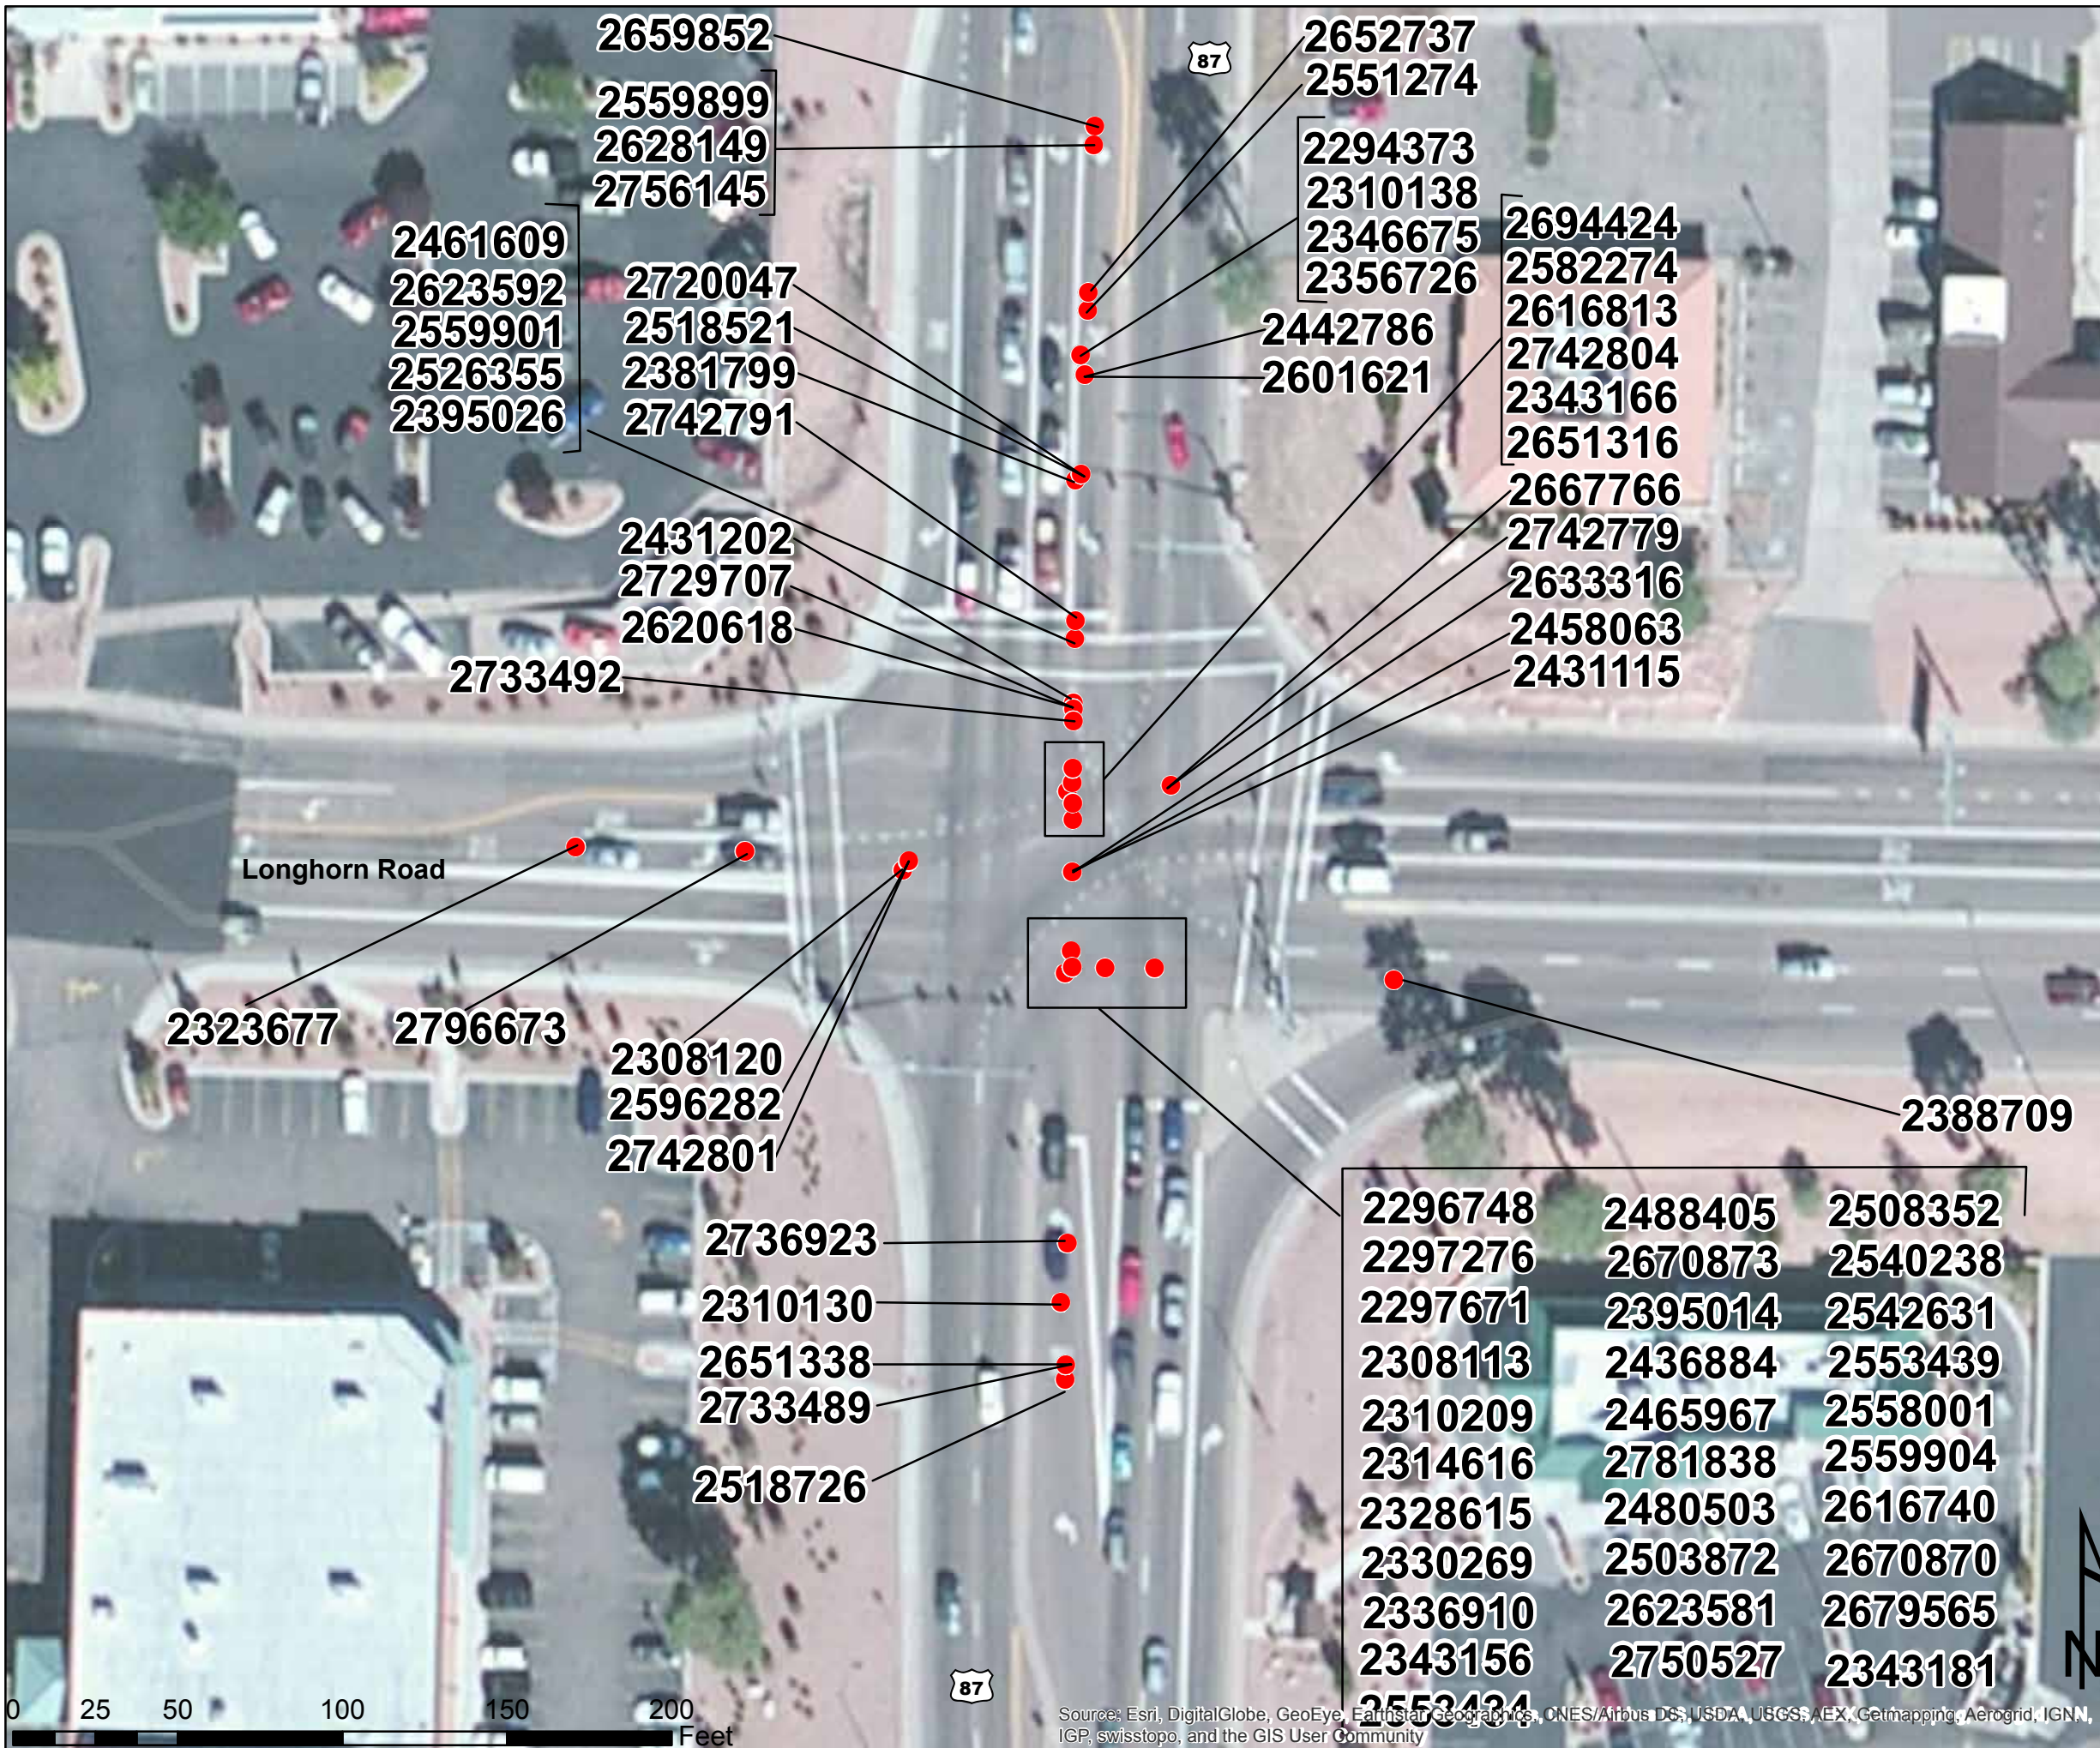
● Individual Crashes 2009-2013

**2805676** Incident Number

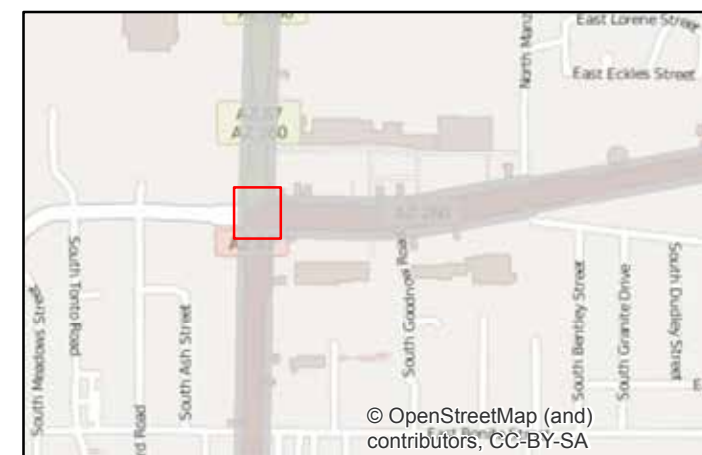
Intersection: SR 87 at Longhorn Road  
 Years: 2009-2013  
 Total Crashes: 78  
 Total Crash Injuries: 26  
 Total Crash Fatalities: 0

Symbols	Types of Collisions
.....	Single Vehicle
□	Pedestrian/ Bicyclist
●	Fatal Accident
○	Injury Accident
◇	Fixed Object/ Animal
→	Rear End
↔	Head On
⌋	Side Swipe
⊙	Out of Control
↙	Left Turn
⊥	Right Angle
↗	Rear to Side/Rear
